APPRAISAL OF

167 Wolverine St
Staten Island, NY 10306

Uniform Residential Appraisal Report

File No. 374-5324447 / 3083580.1

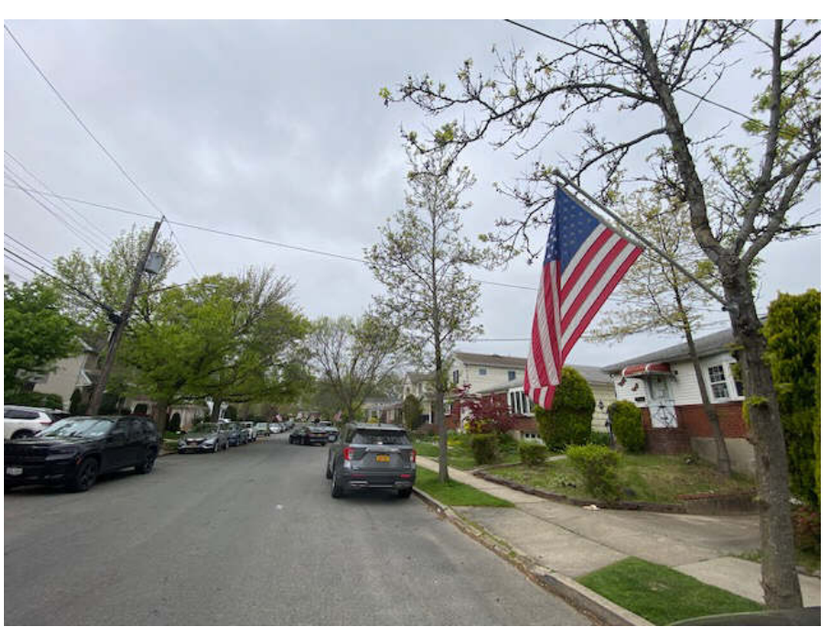
FRONT VIEW OF
SUBJECT PROPERTY
