Uniform Residential Appraisal Report

0322024
File No. REO2024DHUAD

Property Address 2209 Cedar Cir | City Carrollton | State TX | Zip Code 75006-1926
Borrower Kleenex Maker | Owner of Public Record Frohlich Martin L / Frohlich Angela | County Dallas
Legal Description Woodcreek 2Nd Inst Blk H Lot 15 Int201400275760 Dd10132014
Assessor's Parcel # 14-11980-008-015-0000 | Tax Year 2023 | R.E. Taxes $ 574.64
Neighborhood Name Southwest Carrollton | Map Reference 4B-1 | Census Tract 0602.02
Occupant [X] Owner [ ] Tenant [ ] Vacant | Special Assessments $ 0 | [ ] PUD | HOA $ 0 [ ] per year [ ] per month
Property Rights Appraised [X] Fee Simple [ ] Leasehold [ ] Other (describe)
Assignment Type [ ] Purchase Transaction [X] Refinance Transaction [ ] Other (describe)
Lender/Client Purified Water Bank | Address 1111 Main Street
Is the subject property currently offered for sale or has it been offered for sale in the twelve months prior to the effective date of this appraisal? [ ] Yes [X] No

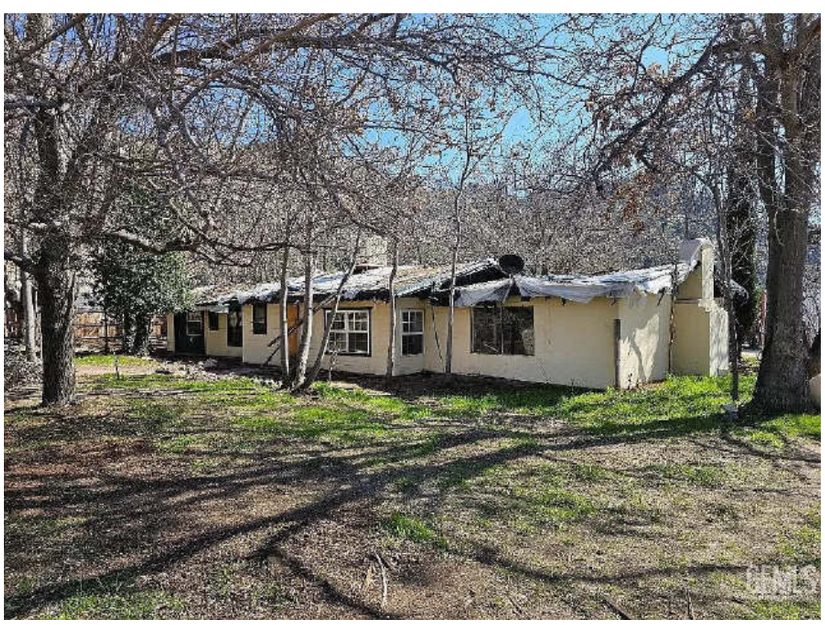
ROOF DAMAGE
