Uniform Residential Appraisal Report

0322024
File No. REO2024DHUAD

Property Address 2209 Cedar Cir | City Carrollton | State TX | Zip Code 75006-1926
Borrower Kleenex Maker | Owner of Public Record Frohlich Martin L / Frohlich Angela | County Dallas
Legal Description Woodcreek 2Nd Inst Blk H Lot 15 Int201400275760 Dd10132014
Assessor's Parcel # 14-11980-008-015-0000 | Tax Year 2023 | R.E. Taxes $ 574.64
Neighborhood Name Southwest Carrollton | Map Reference 4B-1 | Census Tract 0602.02
Occupant [X] Owner [ ] Tenant [ ] Vacant | Special Assessments $ 0 | [ ] PUD | HOA $ 0 [ ] per year [ ] per month
Property Rights Appraised [X] Fee Simple [ ] Leasehold [ ] Other (describe)
Assignment Type [ ] Purchase Transaction [X] Refinance Transaction [ ] Other (describe)
Lender/Client Purified Water Bank | Address 1111 Main Street
Is the subject property currently offered for sale or has it been offered for sale in the twelve months prior to the effective date of this appraisal? [ ] Yes [X] No

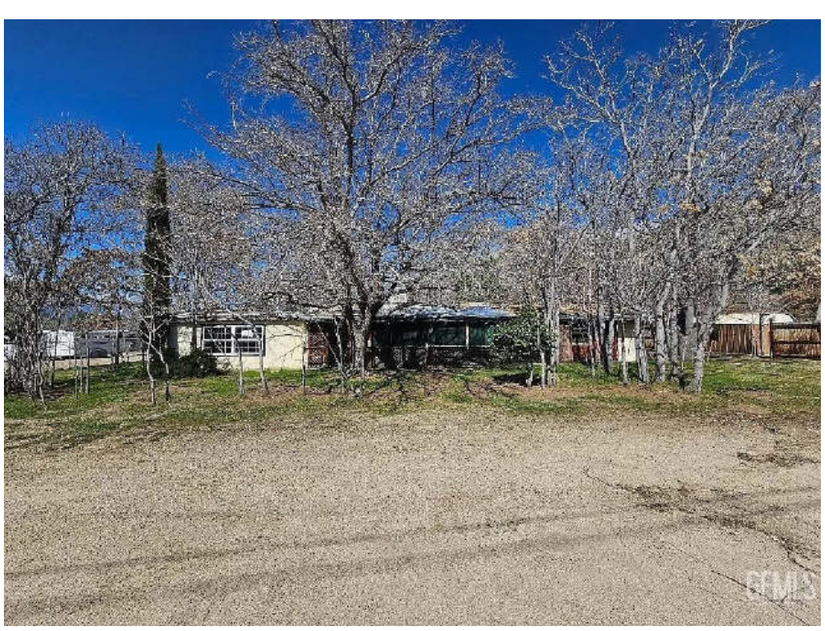
- GSE - RECONCILIATION - Effective Date - is older than 1 year (365 days) from the current date. (ref. FNM0079)
- 1004_05UAD - FRONT VIEW OF SUBJECT PROPERTY - ACI Insights detected that the Subject Front photo contains watermark, indicating a possible compliance issue. Please blur the item(s) found or retake the photo.
