APPRAISAL OF

167 Wolverine St
Staten Island, NY 10306

April 30, 2024

Uniform Residential Appraisal Report

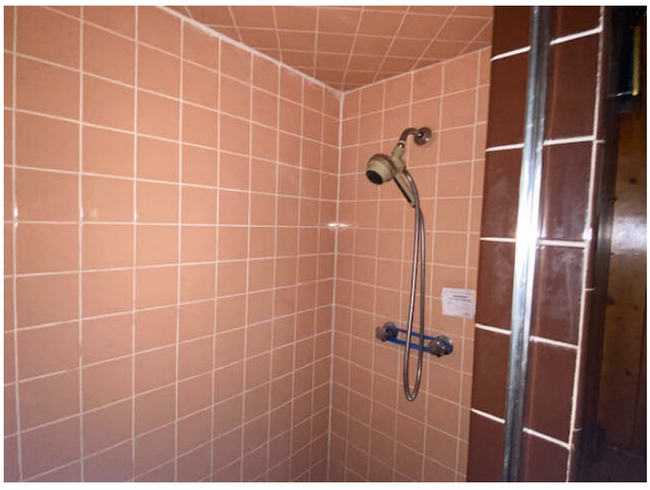
Basement Bath View 2

Basement Den
