Uniform Residential Appraisal Report

File No. 0322024 KernvilleREO2

Property Address 11971 Sierra Way | City Kernville | State CA | Zip Code 93238-9725

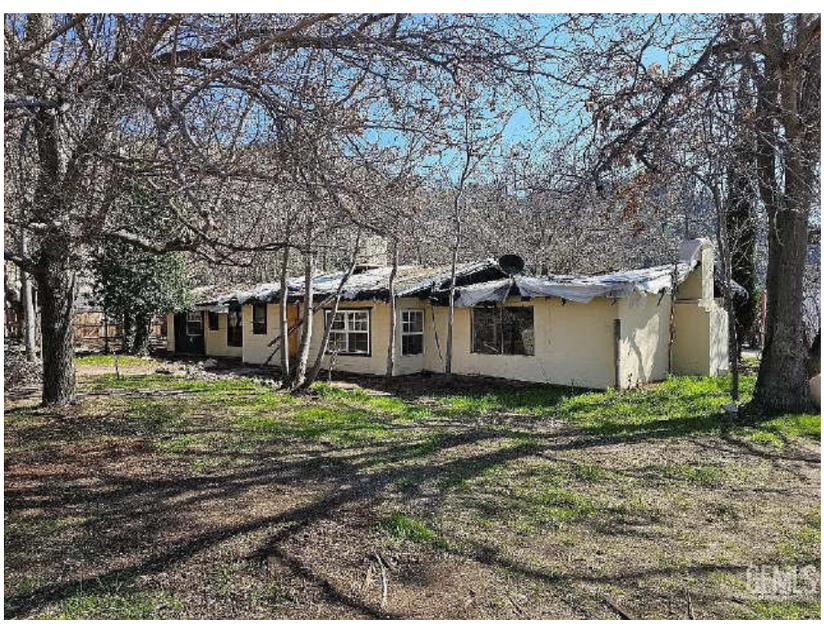
ROOF DAMAGE

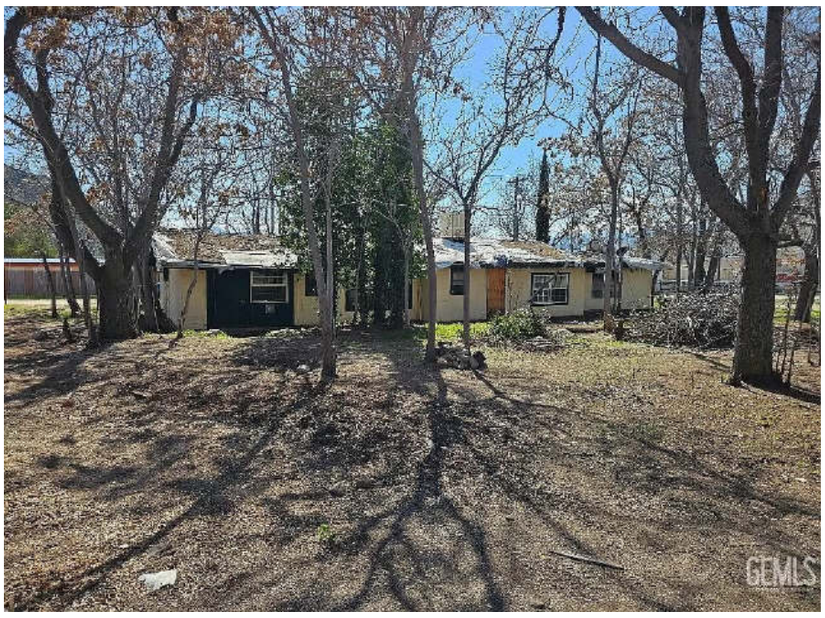
NO BACK DOOR
