DCH Appraisals

Uniform Residential Appraisal Report

0322024
File No. REO2024DHUAD

Property Address 2209 Cedar Cir | City Carrollton | State TX | Zip Code 75006-1926
Borrower Kleenex Maker | Owner of Public Record Frohlich Martin L / Frohlich Angela | County Dallas
Legal Description Woodcreek 2Nd Inst Blk H Lot 15 Int201400275760 Dd10132014
Assessor's Parcel # 14-11980-008-015-0000 | Tax Year 2023 | R.E. Taxes $ 574.64
Neighborhood Name Southwest Carrollton | Map Reference 4B-1 | Census Tract 0602.02
Occupant [X] Owner [ ] Tenant [ ] Vacant | Special Assessments $ 0 | [ ] PUD | HOA $ 0 [ ] per year [ ] per month
Property Rights Appraised [X] Fee Simple [ ] Leasehold [ ] Other (describe)
Assignment Type [ ] Purchase Transaction [X] Refinance Transaction [ ] Other (describe)
Lender/Client Purified Water Bank | Address 1111 Main Street
Is the subject property currently offered for sale or has it been offered for sale in the twelve months prior to the effective date of this appraisal? [ ] Yes [X] No

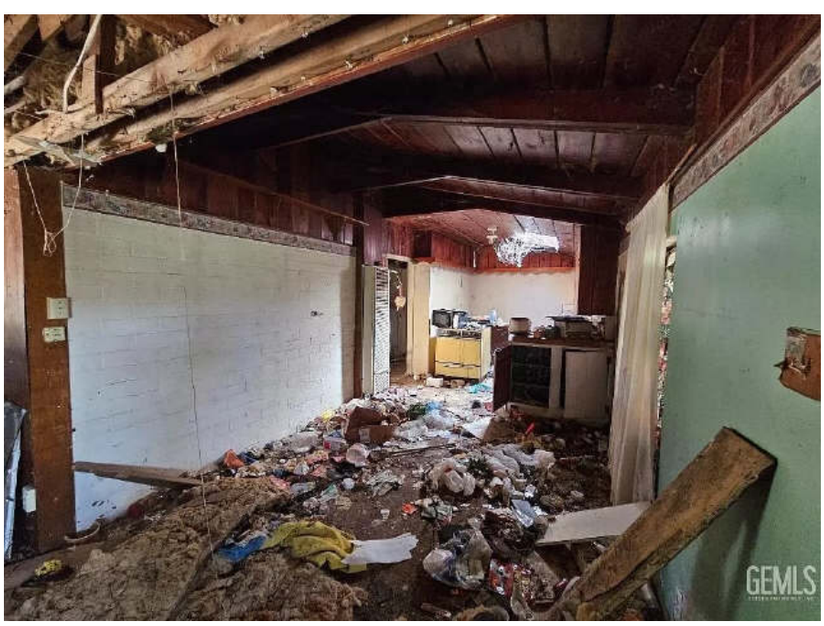
HALL

- 1004_05UAD - REPORT - PHOTOS - ACI Insights detected that a photo on the EXTRA_2_PHOTO_3, page contains cluttered, ceiling_missing, floor_damage, wall_damage_discoloration, ceiling_damage, severity_material, indicating possible damage to the Subject Property. Comment, including a description of the observed damage, is required.
