APPRAISAL OF

167 Wolverine St
Staten Island, NY 10306

April 30, 2024

Uniform Residential Appraisal Report

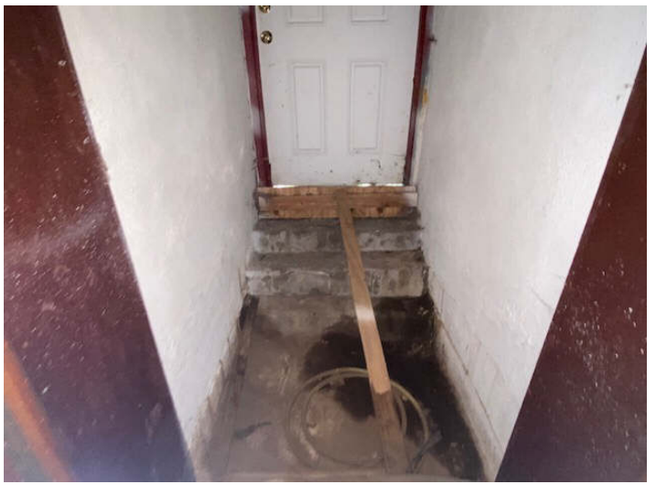
1. Cracks along the foundation-$15,000
2. Side steps need repair-$1,000
3. General clean up-$500
4. Water intrusion into the basement-20,000
5. Gutter needs repair- $8,500
6. Garage needs repair-$5,000

Water Instrusions Into the Basement

Side Steps Need Repair

Cracks Along The Foundation

Gutters need repair

Garage needs repair

The appraiser is not a general contractor, plumber, home inspection, nor electrician. It is advisable for a specialist within their fields to assess the damages.
