Uniform Residential Appraisal Report

File No. 0322024 REO2024DHUAD

Property Address 2209 Cedar Cir | City Carrollton | State TX | Zip Code 75006-1926

SUBJECT PROPERTY PHOTO ADDENDUM

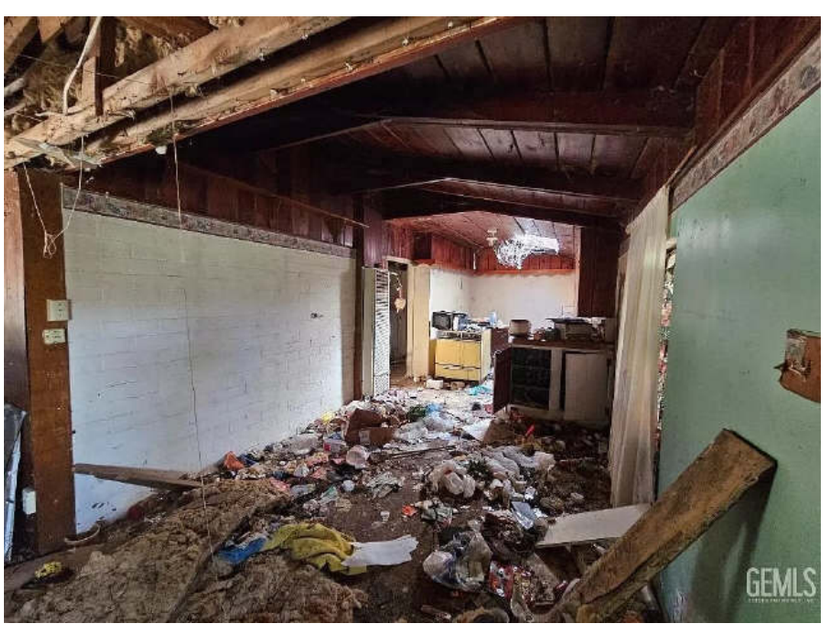
HALL
