DCH Appraisals

Uniform Residential Appraisal Report

0322024
File No. REO2024DHUAD

Property Address 2209 Cedar Cir | City Carrollton | State TX | Zip Code 75006-1926
Borrower Kleenex Maker | Owner of Public Record Frohlich Martin L / Frohlich Angela | County Dallas
Legal Description Woodcreek 2Nd Inst Blk H Lot 15 Int201400275760 Dd10132014
Assessor's Parcel # 14-11980-008-015-0000 | Tax Year 2023 | R.E. Taxes $ 574.64
Neighborhood Name Southwest Carrollton | Map Reference 4B-1 | Census Tract 0602.02
Occupant [X] Owner [ ] Tenant [ ] Vacant | Special Assessments $ 0 | [ ] PUD | HOA $ 0 [ ] per year [ ] per month
Property Rights Appraised [X] Fee Simple [ ] Leasehold [ ] Other (describe)
Assignment Type [ ] Purchase Transaction [X] Refinance Transaction [ ] Other (describe)
Lender/Client Purified Water Bank | Address 1111 Main Street
Is the subject property currently offered for sale or has it been offered for sale in the twelve months prior to the effective date of this appraisal? [ ] Yes [X] No

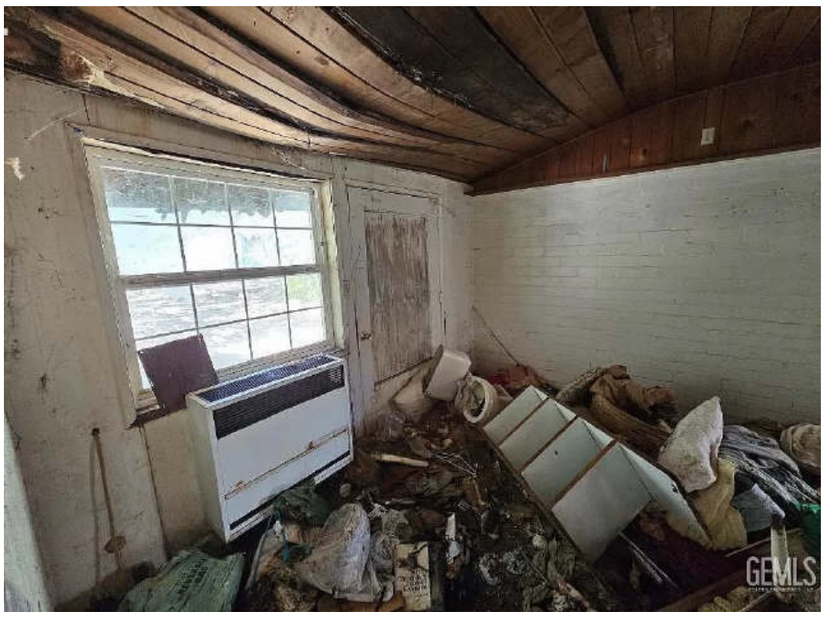
ENCLOSED PATIO

- 1004_05UAD - REPORT - PHOTOS - ACI Insights detected that a photo on the EXTRA_1_PHOTO_1, page contains ceiling_damage_eroded_material, cluttered, wall_damage_discoloration, severity_material, floor_damage, indicating possible damage to the Subject Property. Comment, including a description of the observed damage, is required.

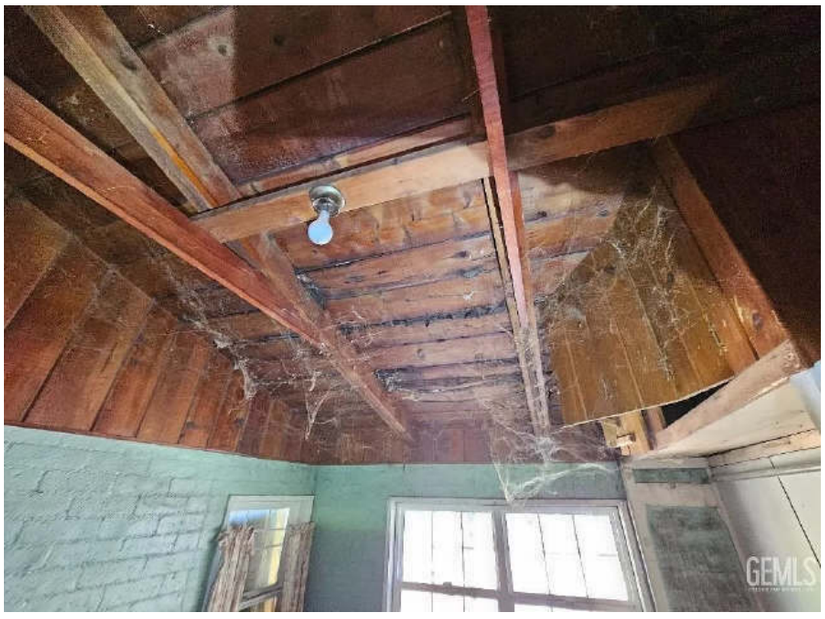
CEILING

- 1004_05UAD - REPORT - PHOTOS - ACI Insights detected that a photo on the EXTRA_1_PHOTO_3, page contains ceiling_damage, ceiling_missing, severity_material, indicating possible damage to the Subject Property. Comment, including a description of the observed damage, is required.
