APPRAISAL OF

167 Wolverine St
Staten Island, NY 10306

Uniform Residential Appraisal Report

File No. 374-5324447 / 3083580.1

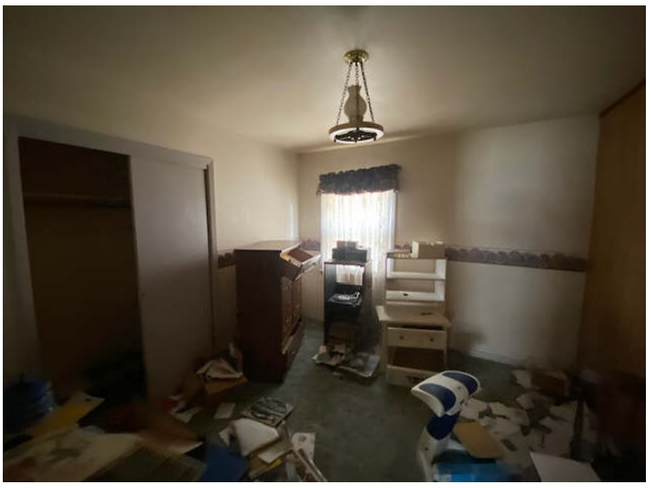
Bath

Bed 1

Bed 2

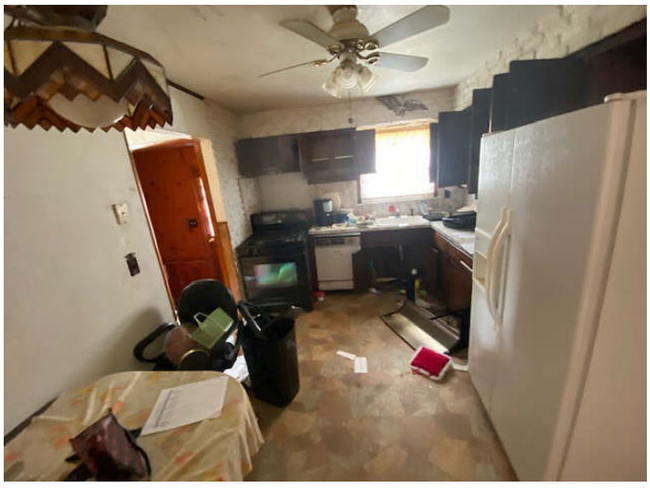
Bed 3

Kitchen

Living Room

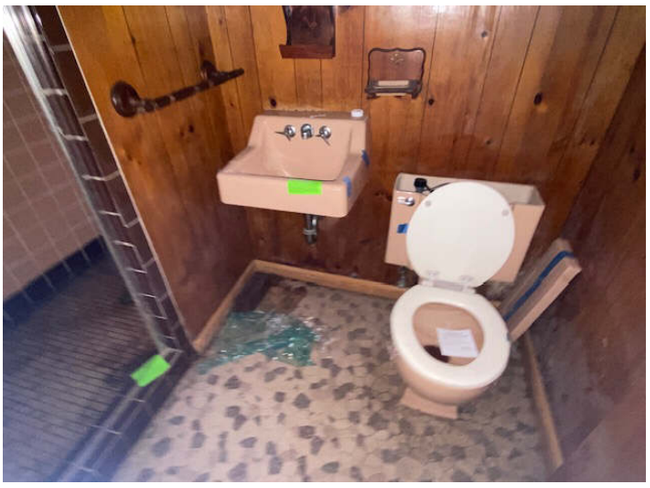
Dining Room

Basement Bath View 1

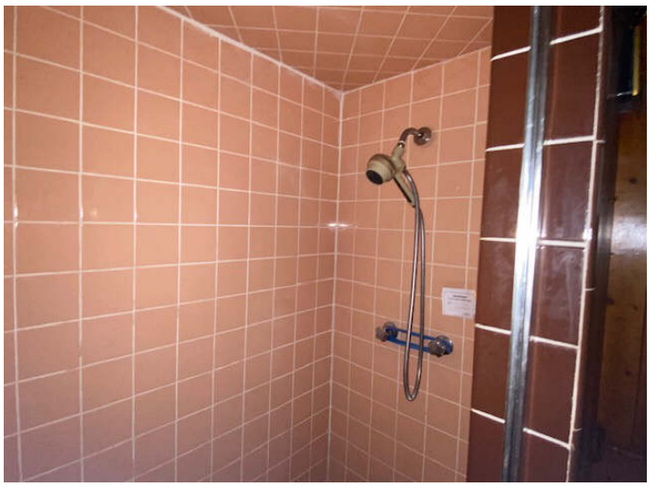
Basement Bath View 2

Basement Den
