Uniform Residential Appraisal Report

57803275689
File No. 082204WVC

Property Address 3055 Old US Highway 395 N | City Washoe Valley | State NV | Zip Code 89704
Borrower Glenn DeWeese & Trista DeWeese | Owner of Public Record Ohison Holly E Lucille L Peterson 1 | County Washoe
Legal Description Rs 4964 Lt A2
Assessor's Parcel # 046 031 47 | Tax Year 2021 | R.E. Taxes $ 4,704
Neighborhood Name Washoe Valley | Map Reference 175 | Census Tract 0032.04
Occupant [ ] Owner [ ] Tenant [X] Vacant | Special Assessments $ 0 [ ] PUD HOA $ 0 [ ] per year [ ] per month
Property Rights Appraised [X] Fee Simple [ ] Leasehold [ ] Other (describe)
Assignment Type [X] Purchase Transaction [ ] Refinance Transaction [ ] Other (describe)
Lender/Client United Federal Credit Union | Address 2807 S. State St., Saint Joseph, MI 49085
Is the subject property currently offered for sale or has it been offered for sale in the twelve months prior to the effective date of this appraisal? [X] Yes [ ] No

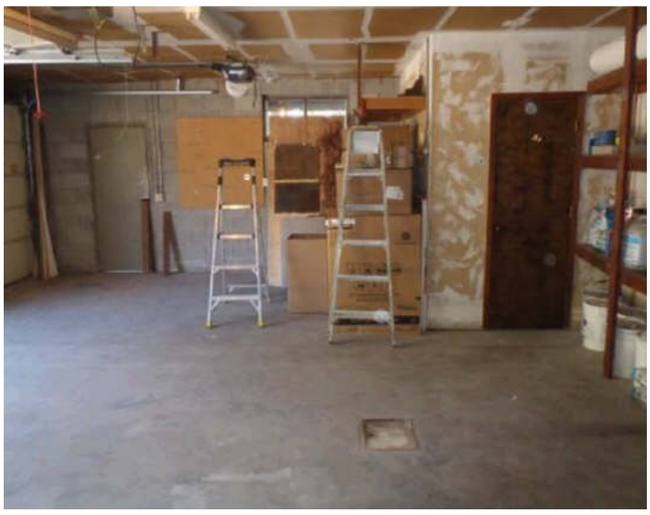
Smoke Detector

The appraiser is not a licensed contractor or home inspector and no warranty is made. Apparent visible deficiencies were noted above. No other visible deficiencies noted that would affect the subject properties livability, soundness or structural integrity - see limiting condition #5. Utilities were on and in working order at time of inspection. The subject has a broken sliding glass door from the master bedroom to the deck, the door needs to be repaired/replaced. Kitchen needs to be repaired and finished, repair the holes in the kitchen walls, install kitchen counters, install kitchen appliances installed. Double strap hot water heater to code. Install batteries and confirm smoke detectors are operable.
